Analysis and mapping of natural hazards using common photography

Landslide in Brienz/Schwanden (Canton Bern, Switzerland, 1896)

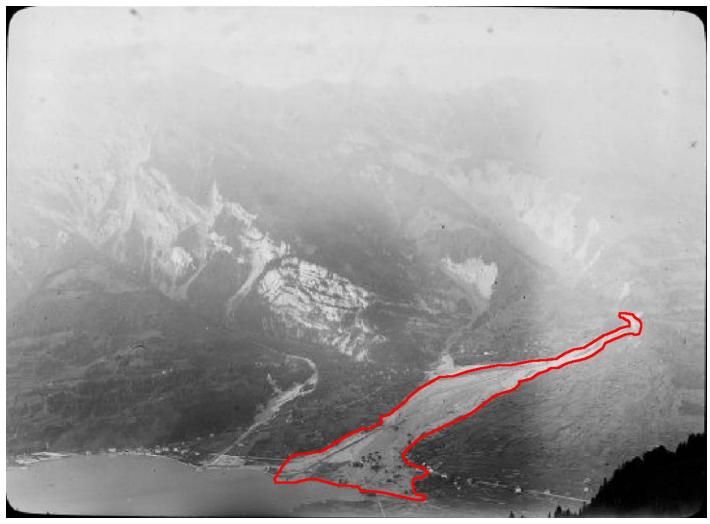
Debris flow on the 1896 photograph (ETH Library).

- Rough estimate based on existing event descriptions
- Precise cartography by georeferencing an ETH Library image

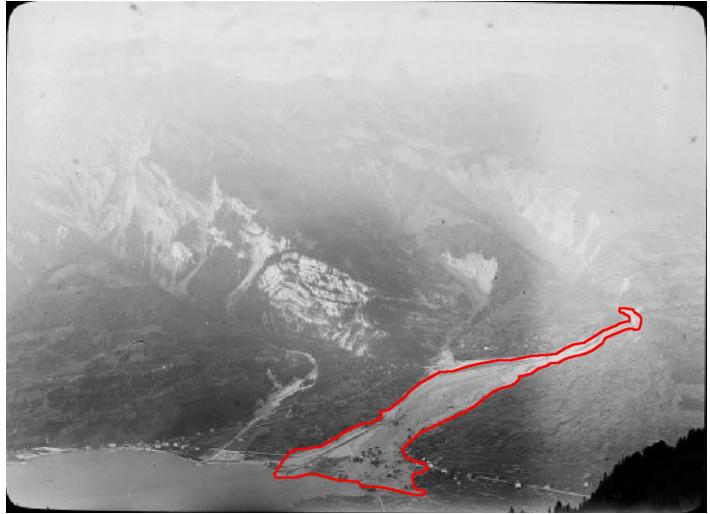
Debris flow on the 1896 photograph (ETH Library).

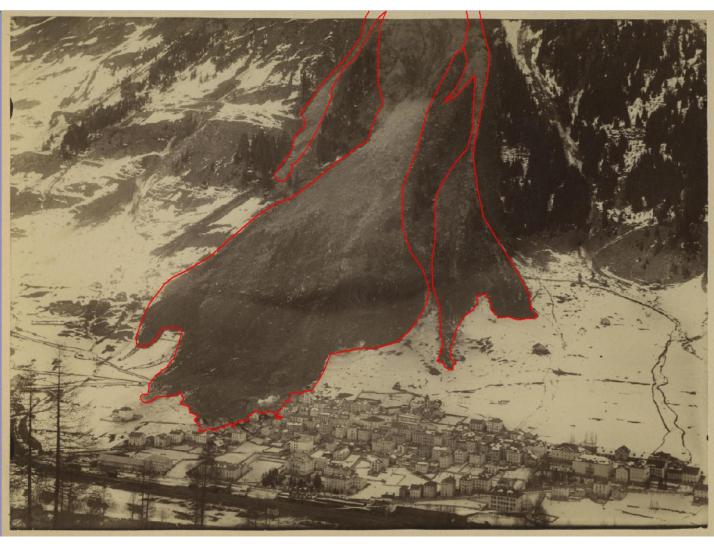
Partial photograph on the rockslide area.

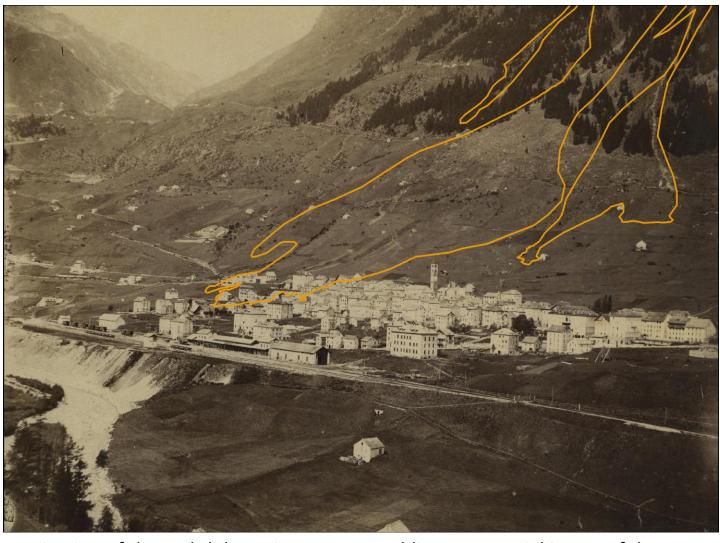
Projection of the rockslide perimeter on an oblique terrestrial image of the area prior to the event.

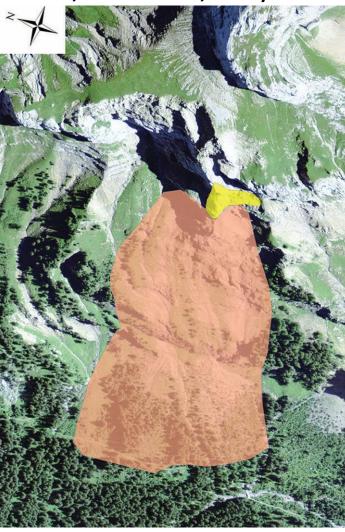
Projection of the detachment (yellow) and transit/deposit (orange) zone on the 2017 orthophoto (swisstopo).

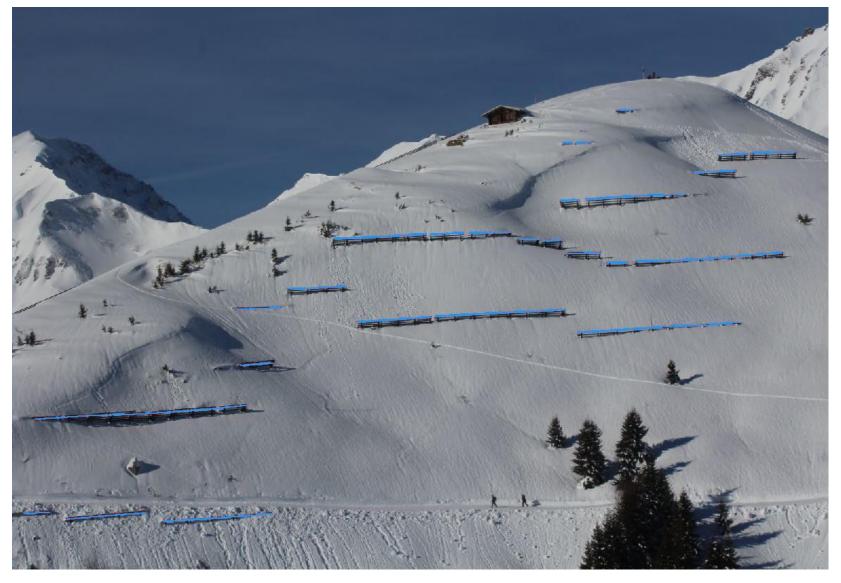
Partial blanketing of the snow bridges, documented during a helicopter mission on January 24, 2018.

- January 24: helicopter mission after end of heavy snowfall
- Detection of partial blanketing of the snow bridges
- Reduced protective function

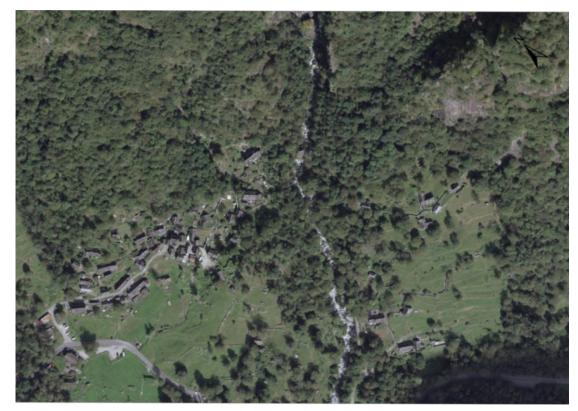
Orthophoto of 2021 (swisstopo).

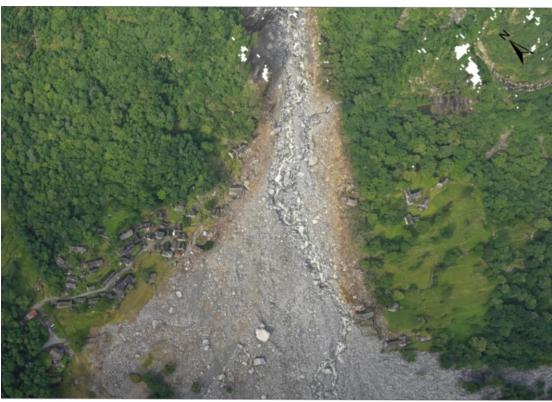
Orthorectification by *image2world* of a *swisstopo* NADIR image immediately after the event (June 30, 2024).

- image2world orthorectification of a swisstopo NADIR photo
- Immediate (1/2 hour) and precise (accuracy < 1m) result

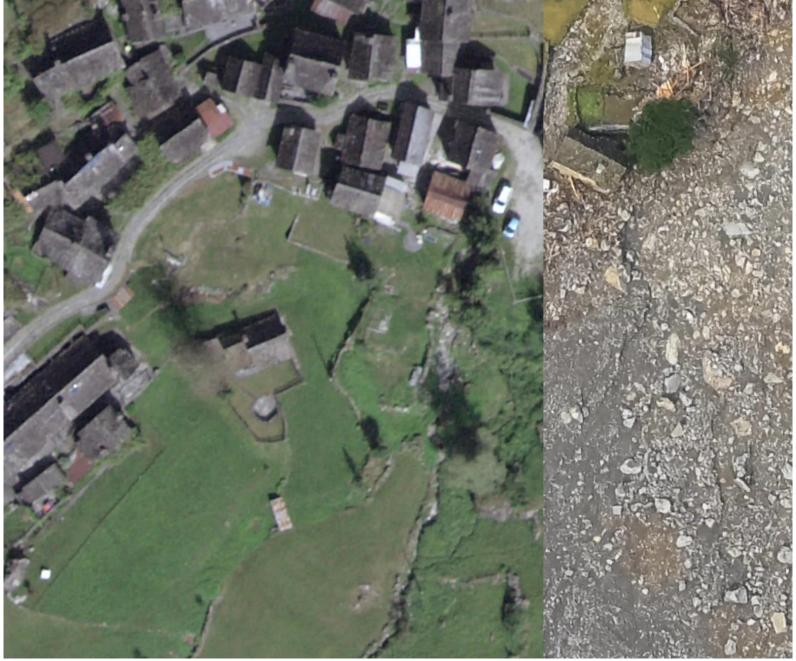
The landslide in Fontana in Val Bavona (Ticino, Switzerland): orthorectification of an aerial photograph taken by *swisstopo* immediately after the event superimposed on *swisstopo* 's 2021 orthophoto.

image2world georeferenced the landslide by orthorectifying a swisstopo photograph taken immediately after the event. The impressive image shows how the landscape has radically changed. The systematic documentation and recording of these events is a very effective way to better understand the phenomena, improving the institutional infrastructure and preventing future damage.

The comparison of before and after the event gives a detailed overview of the catastrophe.
